# RESTORATION OF GANE ENGINE

Firstly the name Gane, this came about as the engine came off a Gane milking machine. In fact it is a Ronaldson and Tippet two (2) horsepower straight petrol engine dated October 1939, engine number 15775.

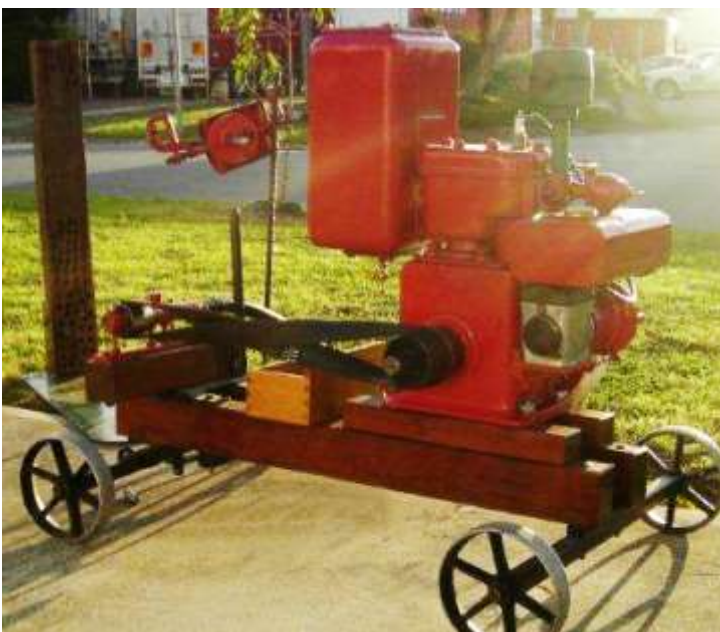
*Gane engine with attached Post drill*

The remainder of the job was fairly straight forward assembly and painting. Clean up the fence post drill, paint it, build a trolley and belt system to couple the two together. All complete but no fence post for drilling displays, so make a plate and bracket to hold a fence post. When I went to start the engine for the first time, I was just turning it over gently to make sure everything was working and it started.

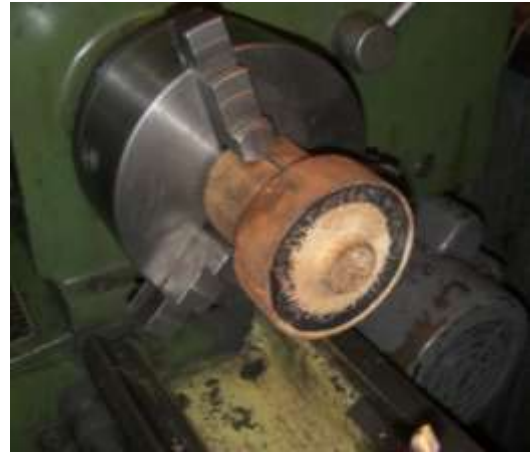
*Demonstrates the machined ring sitting in the recessed wooden block in the lathe.*

DO NOT glue the ends of the O ring as you can buy a special glue to do this. I then measured my piston for rings and went to Antique Motor Spares, John Biddle. He has several tea chests full of piston rings, all sizes, all shapes. After going through most of one tea chest I found 4 compression rings of the desired size. This was two for the top of the piston and one to make a ring, if I remember correctly  $1/16''$  thick. This was to fit into the oil groove with the O ring as the groove was  $3/16''$  wide and  $1/8''$  deep, therefore I required a ring  $1/16''$  wide. Now how do I reduce a  $3/16''$  wide piston ring to  $1/16''$ . I put a block of wood into the lathe and bored a hole up the end of it to the diameter of the Gane engine bore, only bored about  $1/4''$  deep.

I put the piston ring into this recess and started to face it off. It flew out of a few times but did not break. I kept **this process going, removing the ring to measure it at regular intervals.** Eventually I had a  $1/16''$  wide piston ring and I did not even require the fourth spare ring.

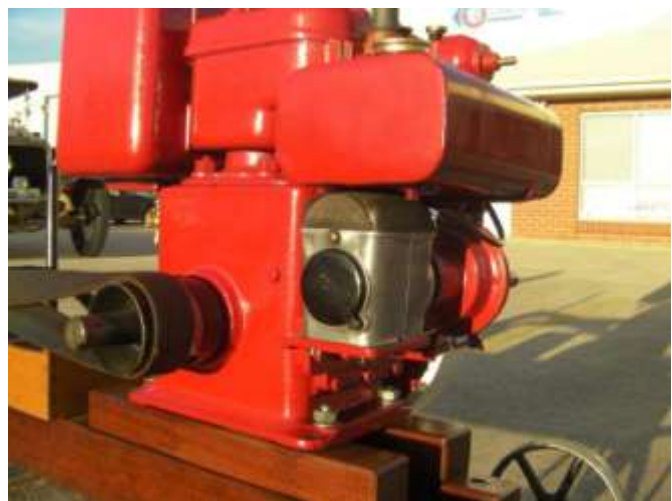
*Gane engine showing the vertical mounted magneto*

Something that has always intrigued me with this engine is the magneto is mounted up the right way as most Ronaldson and Tippett engines the magneto is mounted upside down. If anyone can explain why this is so I would appreciate a reply.
