# RESTORATION OF GANE ENGINE

Firstly the name Gane, this came about as the engine came off a Gane milking machine. In fact it is a Ronaldson and Tippet two (2) horsepower straight petrol engine dated October 1939, engine number 15775.

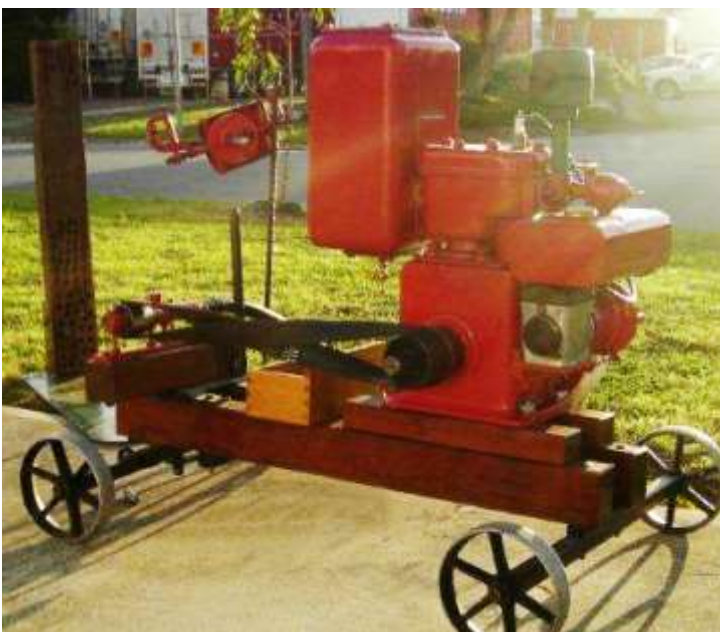
*Gane engine with attached Post drill*

The remainder of the job was fairly straight forward assembly and painting. Clean up the fence post drill, paint it, build a trolley and belt system to couple the two together. All complete but no fence post for drilling displays, so make a plate and bracket to hold a fence post. When I went to start the engine for the first time, I was just turning it over gently to make sure everything was working and it started.

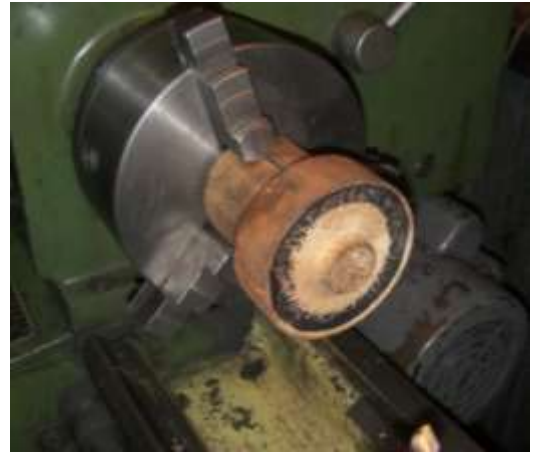
*Demonstrates the machined ring sitting in the recessed wooden block in the lathe.*

DO NOT glue the ends of the O ring as you can buy a special glue to do this. I then measured my piston for rings and went to Antique Motor Spares, John Biddle. He has several tea chests full of piston rings, all sizes, all shapes. After going through most of one tea chest I found 4 compression rings of the desired size. This was two for the top of the piston and one to make a ring, if I remember correctly  $1/16''$  thick. This was to fit into the oil groove with the O ring as the groove was  $3/16''$  wide and  $1/8''$  deep, therefore I required a ring  $1/16''$  wide. Now how do I reduce a  $3/16''$  wide piston ring to  $1/16''$ . I put a block of wood into the lathe and bored a hole up the end of it to the diameter of the Gane engine bore, only bored about  $1/4''$  deep.

I put the piston ring into this recess and started to face it off. It flew out of few times but did not break. I kept **this process going, removing the ring to measure it at regular intervals.** Eventually I had a  $1/16''$  wide piston ring and I did not even require the fourth spare ring.

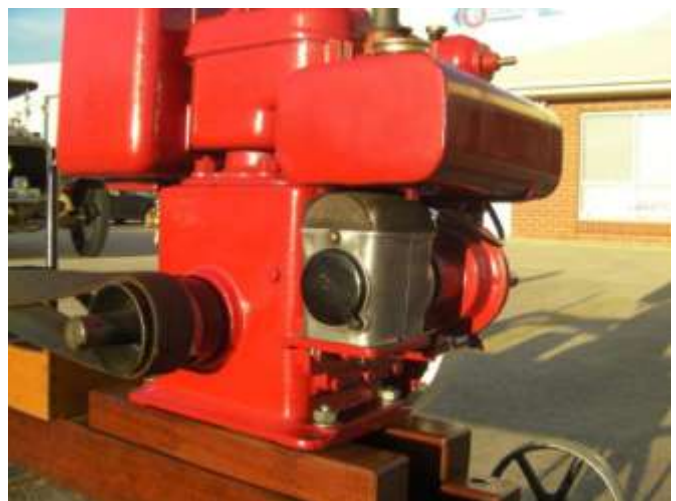
*Gane engine showing the vertical mounted magneto*

Something that has always intrigued me with this engine is the magneto is mounted up the right way as most Ronaldson and Tippett engines the magneto is mounted upside down. If anyone can explain why this is so I would appreciate a reply.
